An Overview of Mangrove Rehabilitation Efforts in Jamaica

*Presenter: Camilo Trench M Sc. and PhD Candidate
Chief Scientific Officer, UWI DBML*

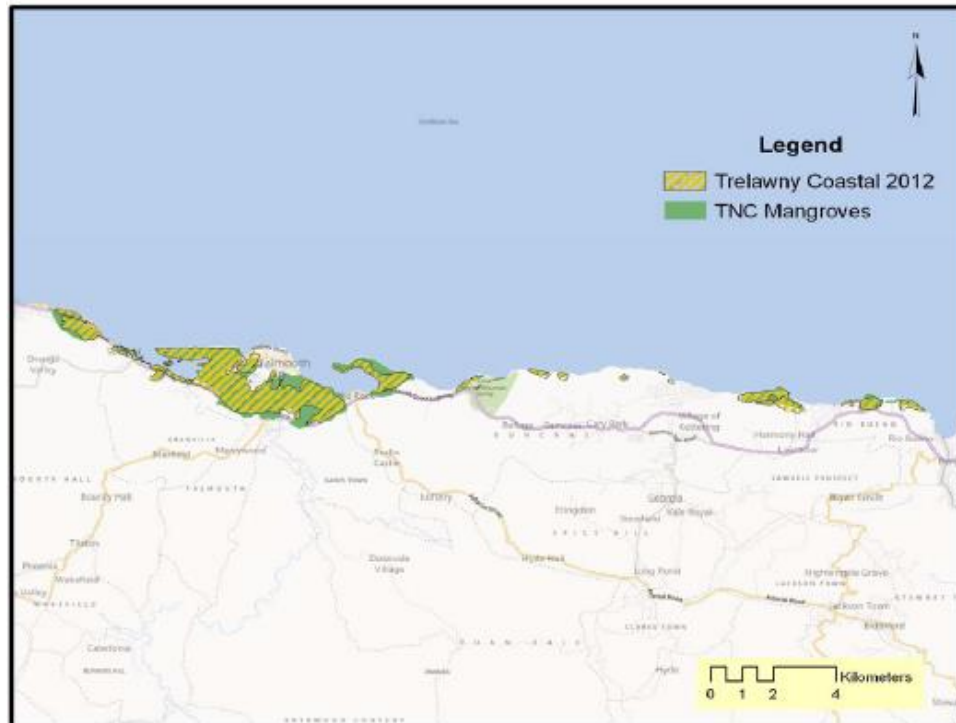
Figure 3: Final coverage of Wetland along the coast of Falmouth as per results of verification exercise

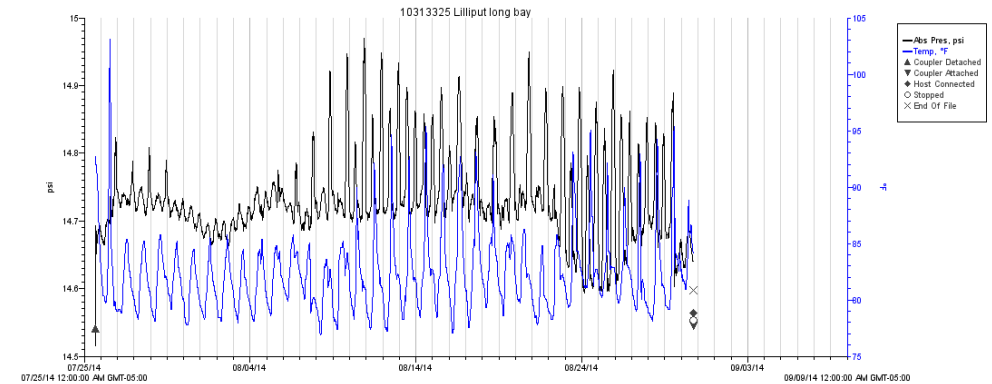
- **Tidal heights** (degree of wetting) using an Onset (U20-001-01-Ti) Hobo water level logger: placed at the observed/apparent high tide reference area and at the highest elevation of the impact sites.

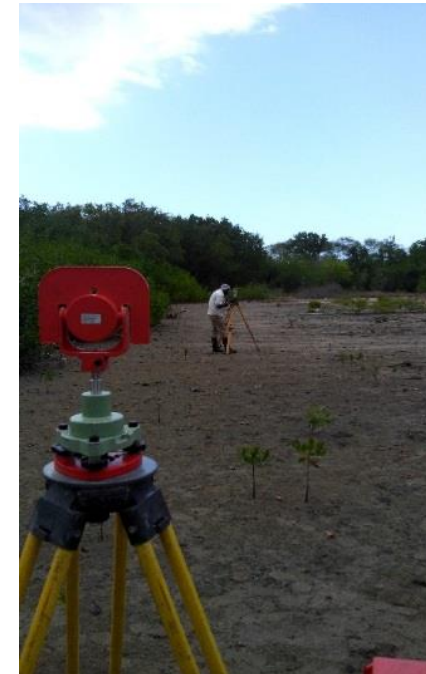
- **Topographic surveys** - spot heights to calculate slope of degraded areas (and periphery of control site) and substrate volumes; **more advanced methods exist*

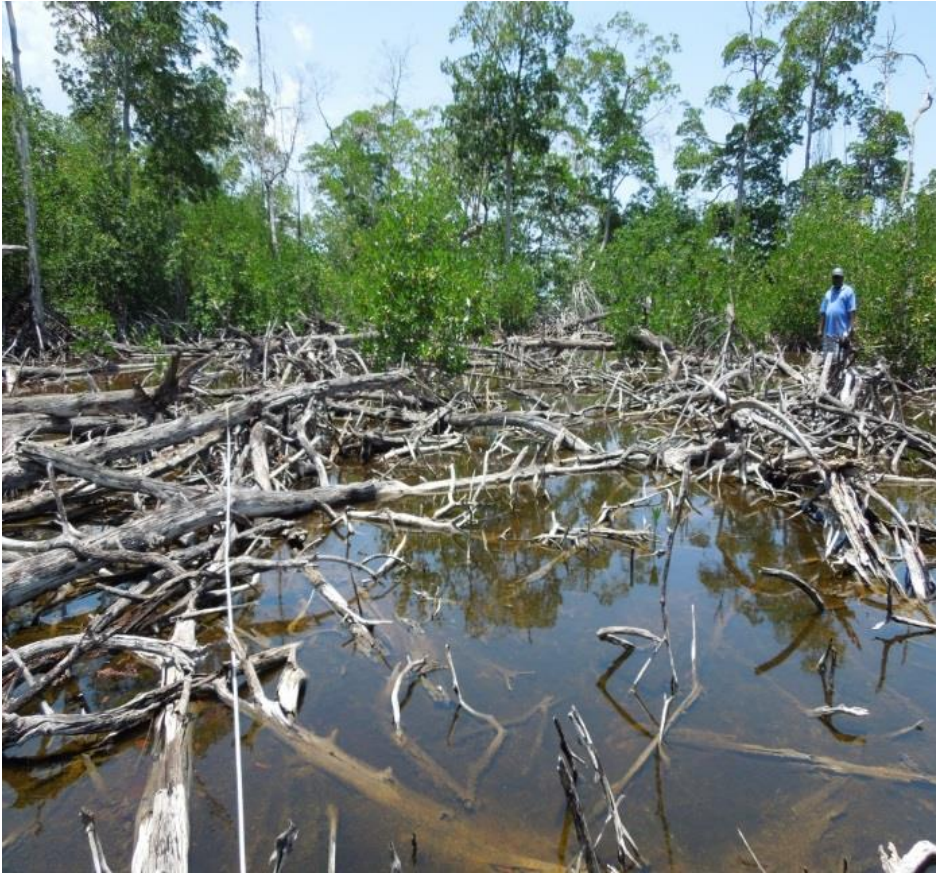
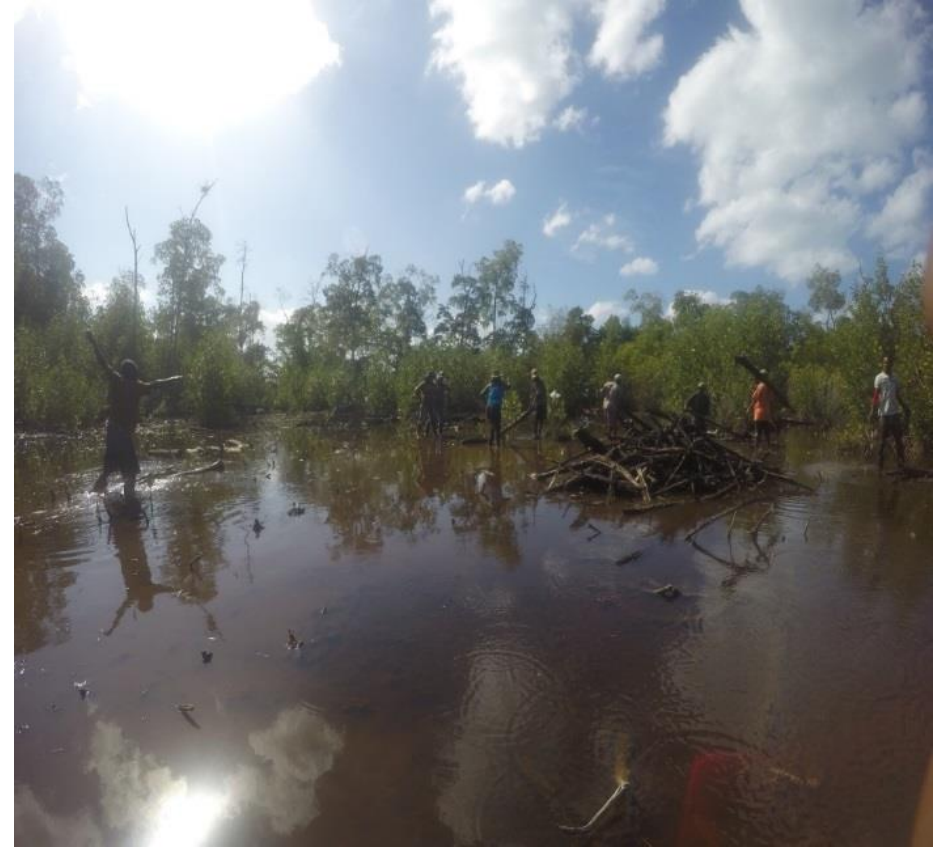
Pre and post clean-up of hurricane damaged site

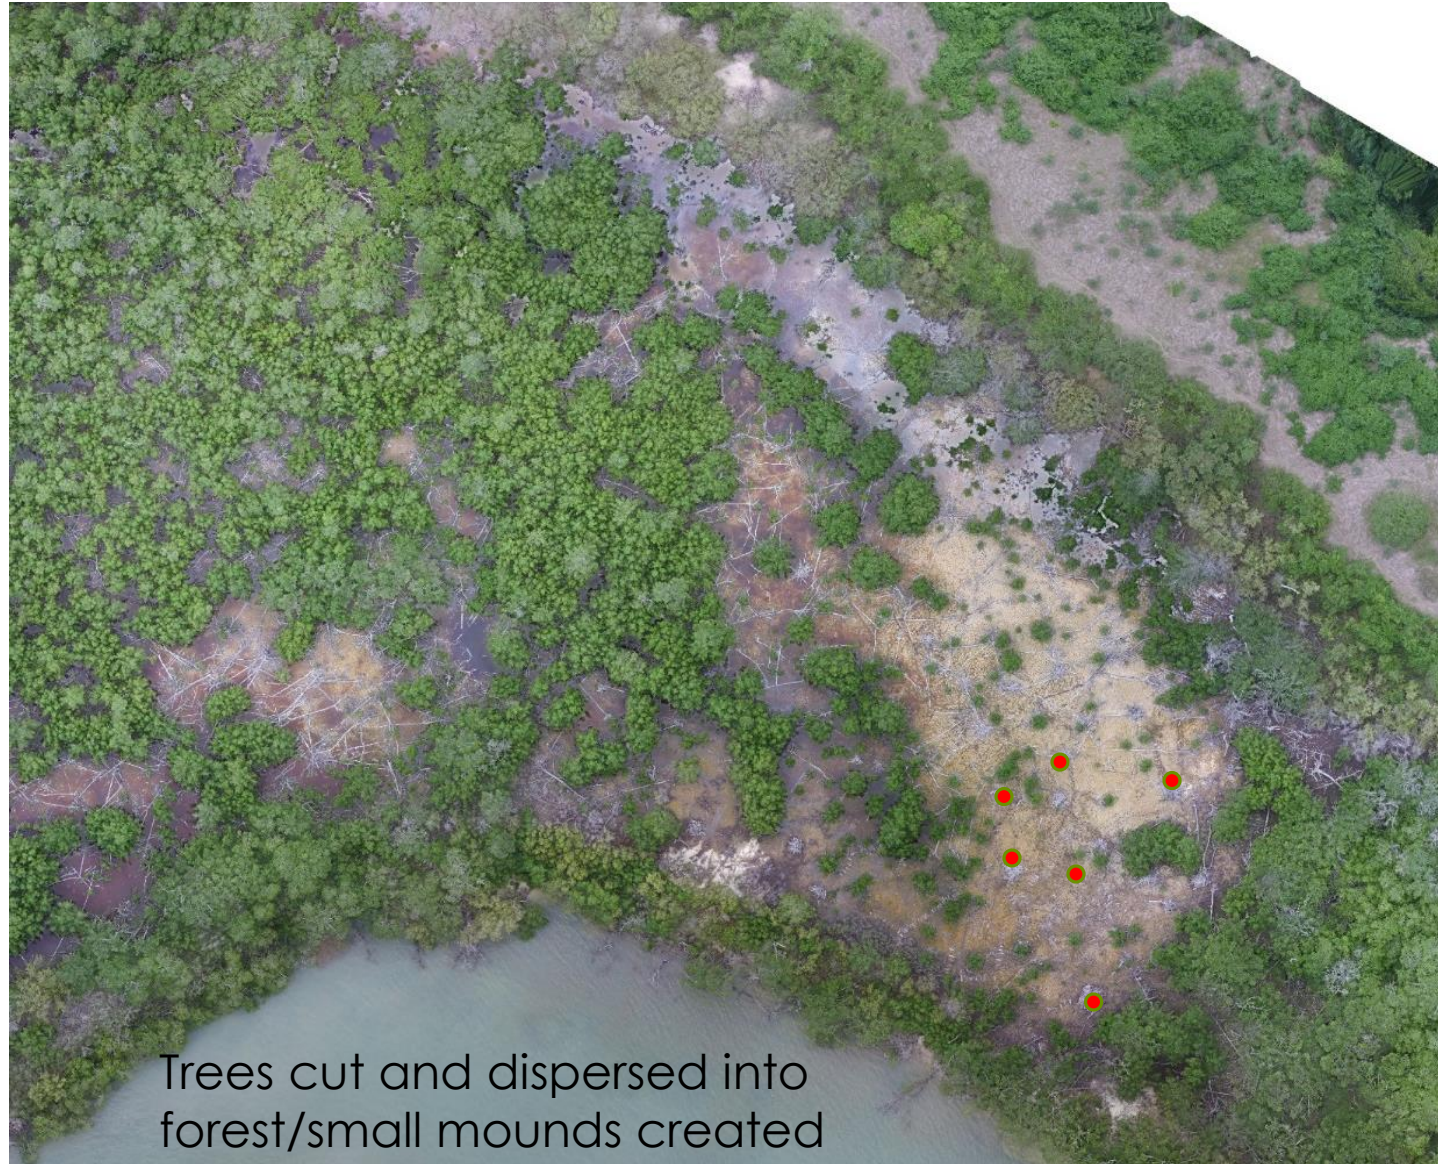
Malcolm's Bay-2016

Trees cut and dispersed into
forest/small mounds created

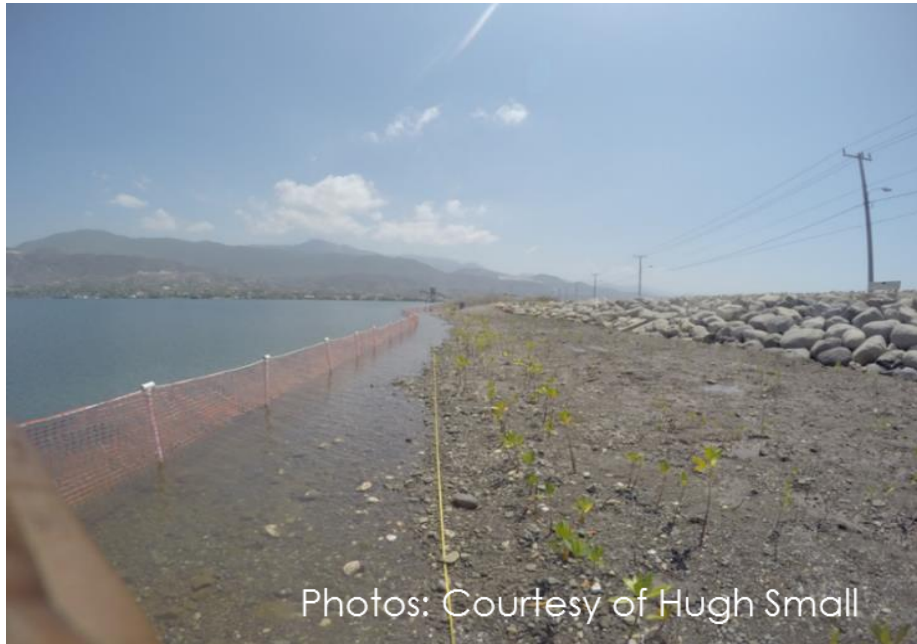
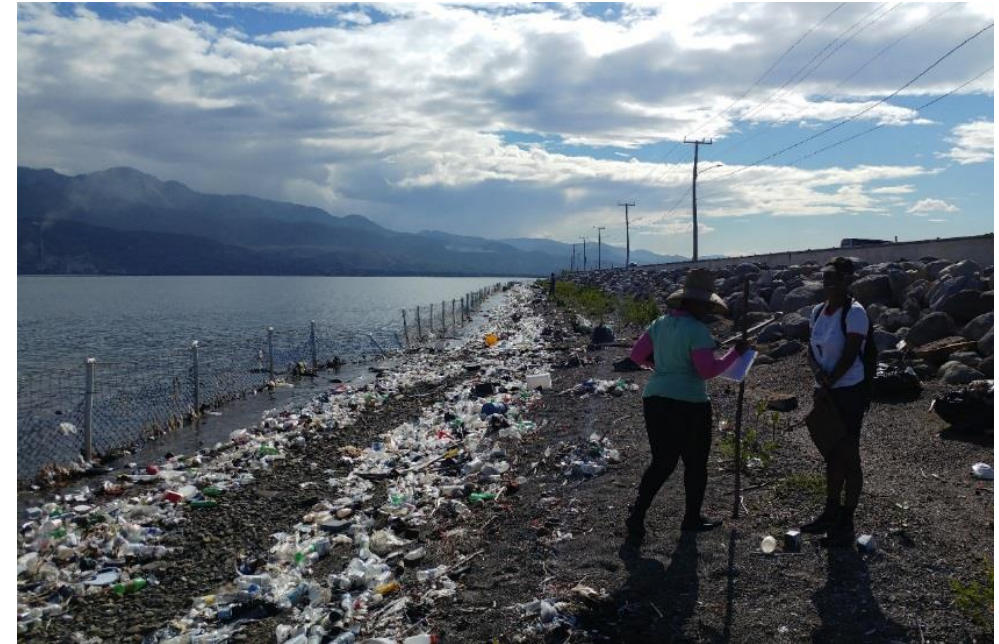
Solid waste management(70% of project budget) key to mangrove sapling survival

- ✓ 70% survival over **12 months**
- ✓ Flowering *Avicennia*
- ✓ Increase in monitoring indices (height, # leaves)
- ✓ Faunal recruitment(snails, fishes, birds, **people ***)

- Govt. agency paused payments (no cleaning, fence breached)
- No new seedlings survive (despite falling from parents)
- **40% overall survival(18 months survey)**

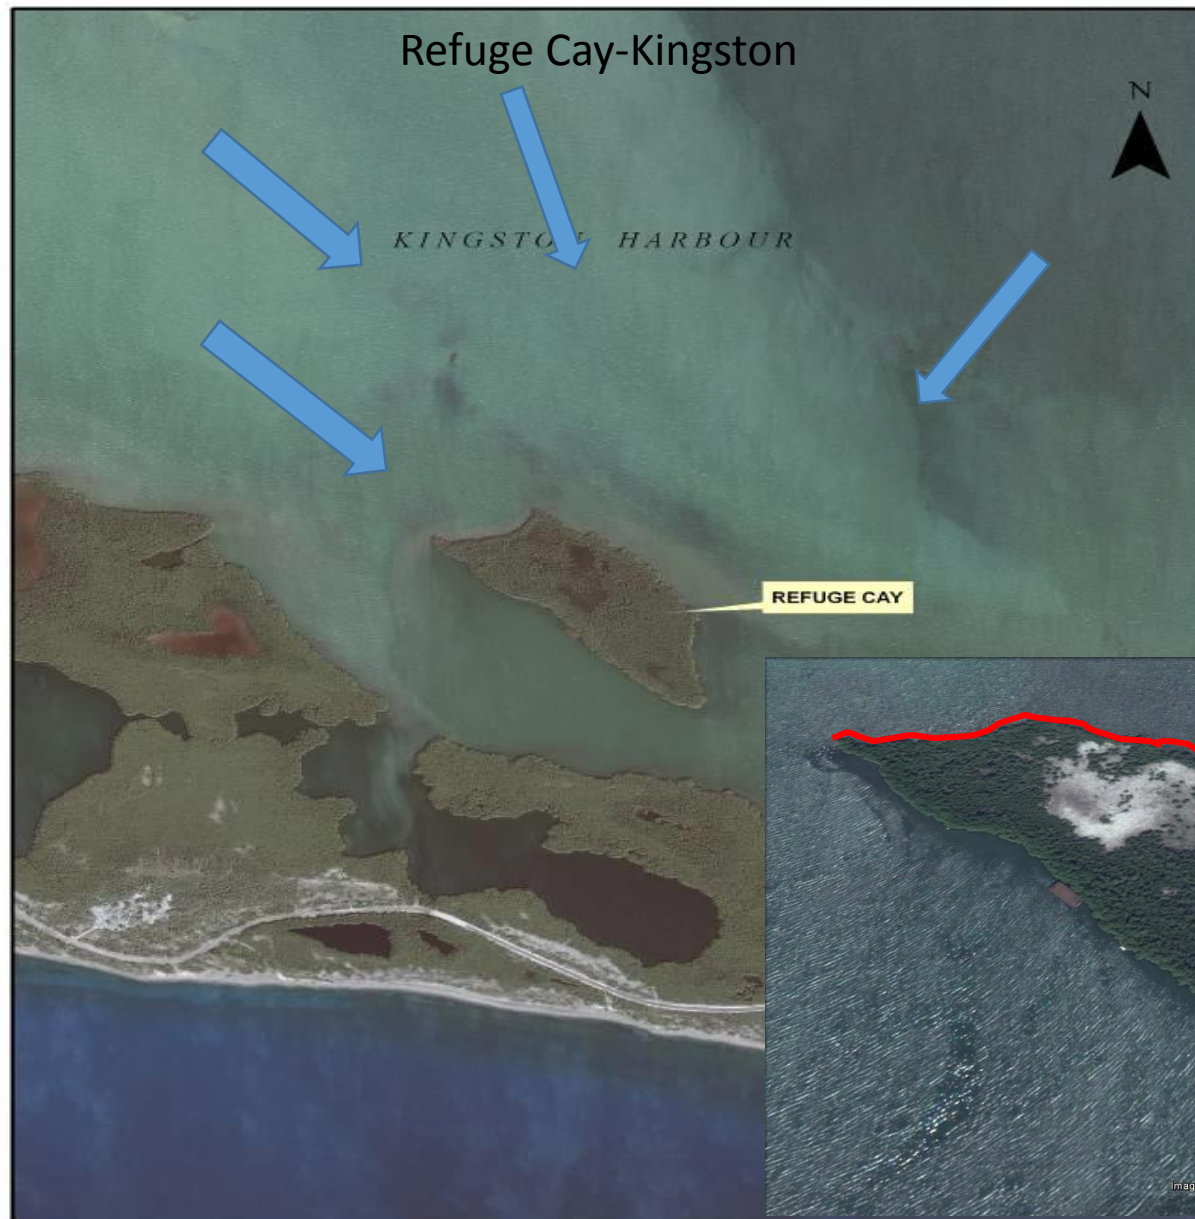
Map of Refuge Cay 2002.

Scale 1cm =122.4km

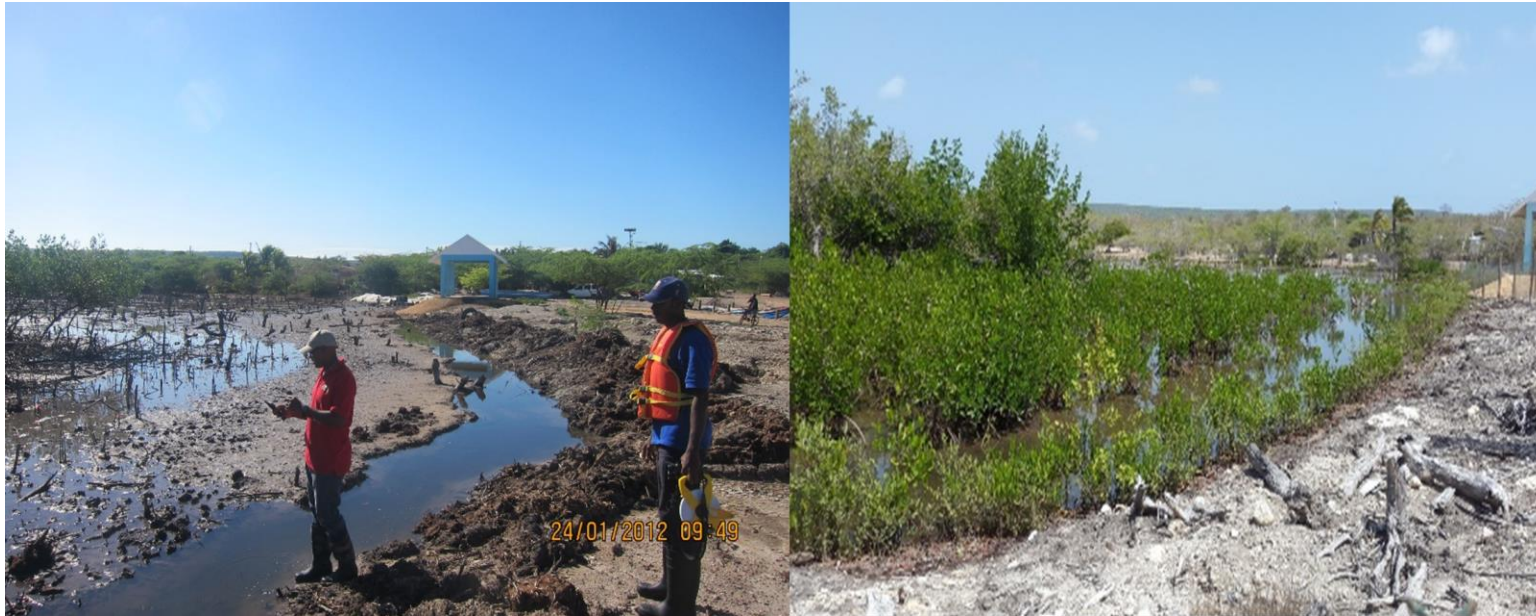
Time 0

After 24 months

Transplants: 40% survival

Recruits: 127% increase

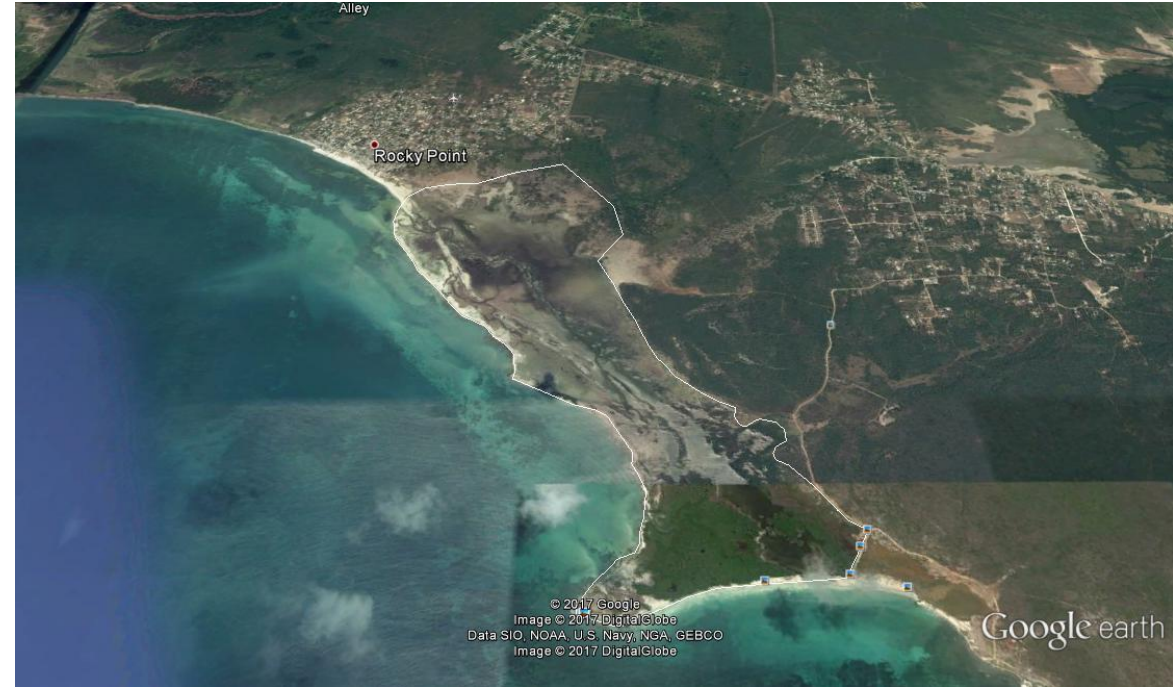
19 acres reduced to 1 acre in 15 years

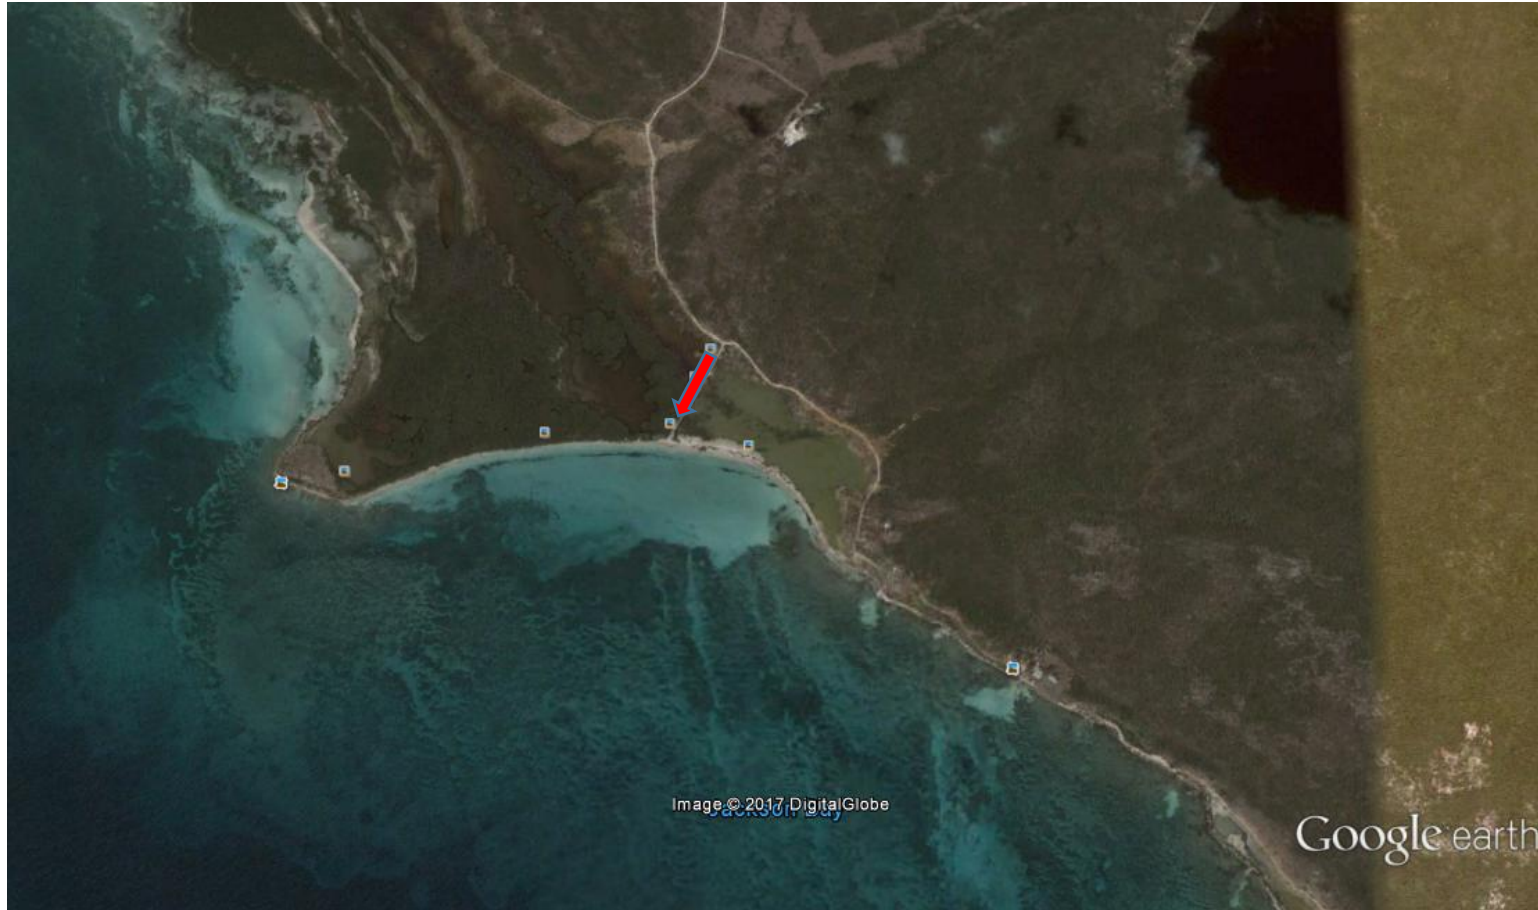
Jackson Bay Beach

Need to re-open drainage connection-road has cut off mangrove connection
